St. Patrick's RC Church, Felling **Revisited - 2015**

In 2014 St. Patrick's RC Church, Felling was awarded a grant of almost £90,000 from The Heritage Lottery Fund to renovate the steps leading up to the processional entrance of the Church. These steps had deteriorated to such an extent that they were deemed unsafe.

This edition is a pictorial record of the work carried out during the renovation and is a sequel to "The History of St. Patrick's RC Church, Felling 1895 - 2014" which covers the history of Catholicism in Felling and in particular the history of St. Patrick's Parish.

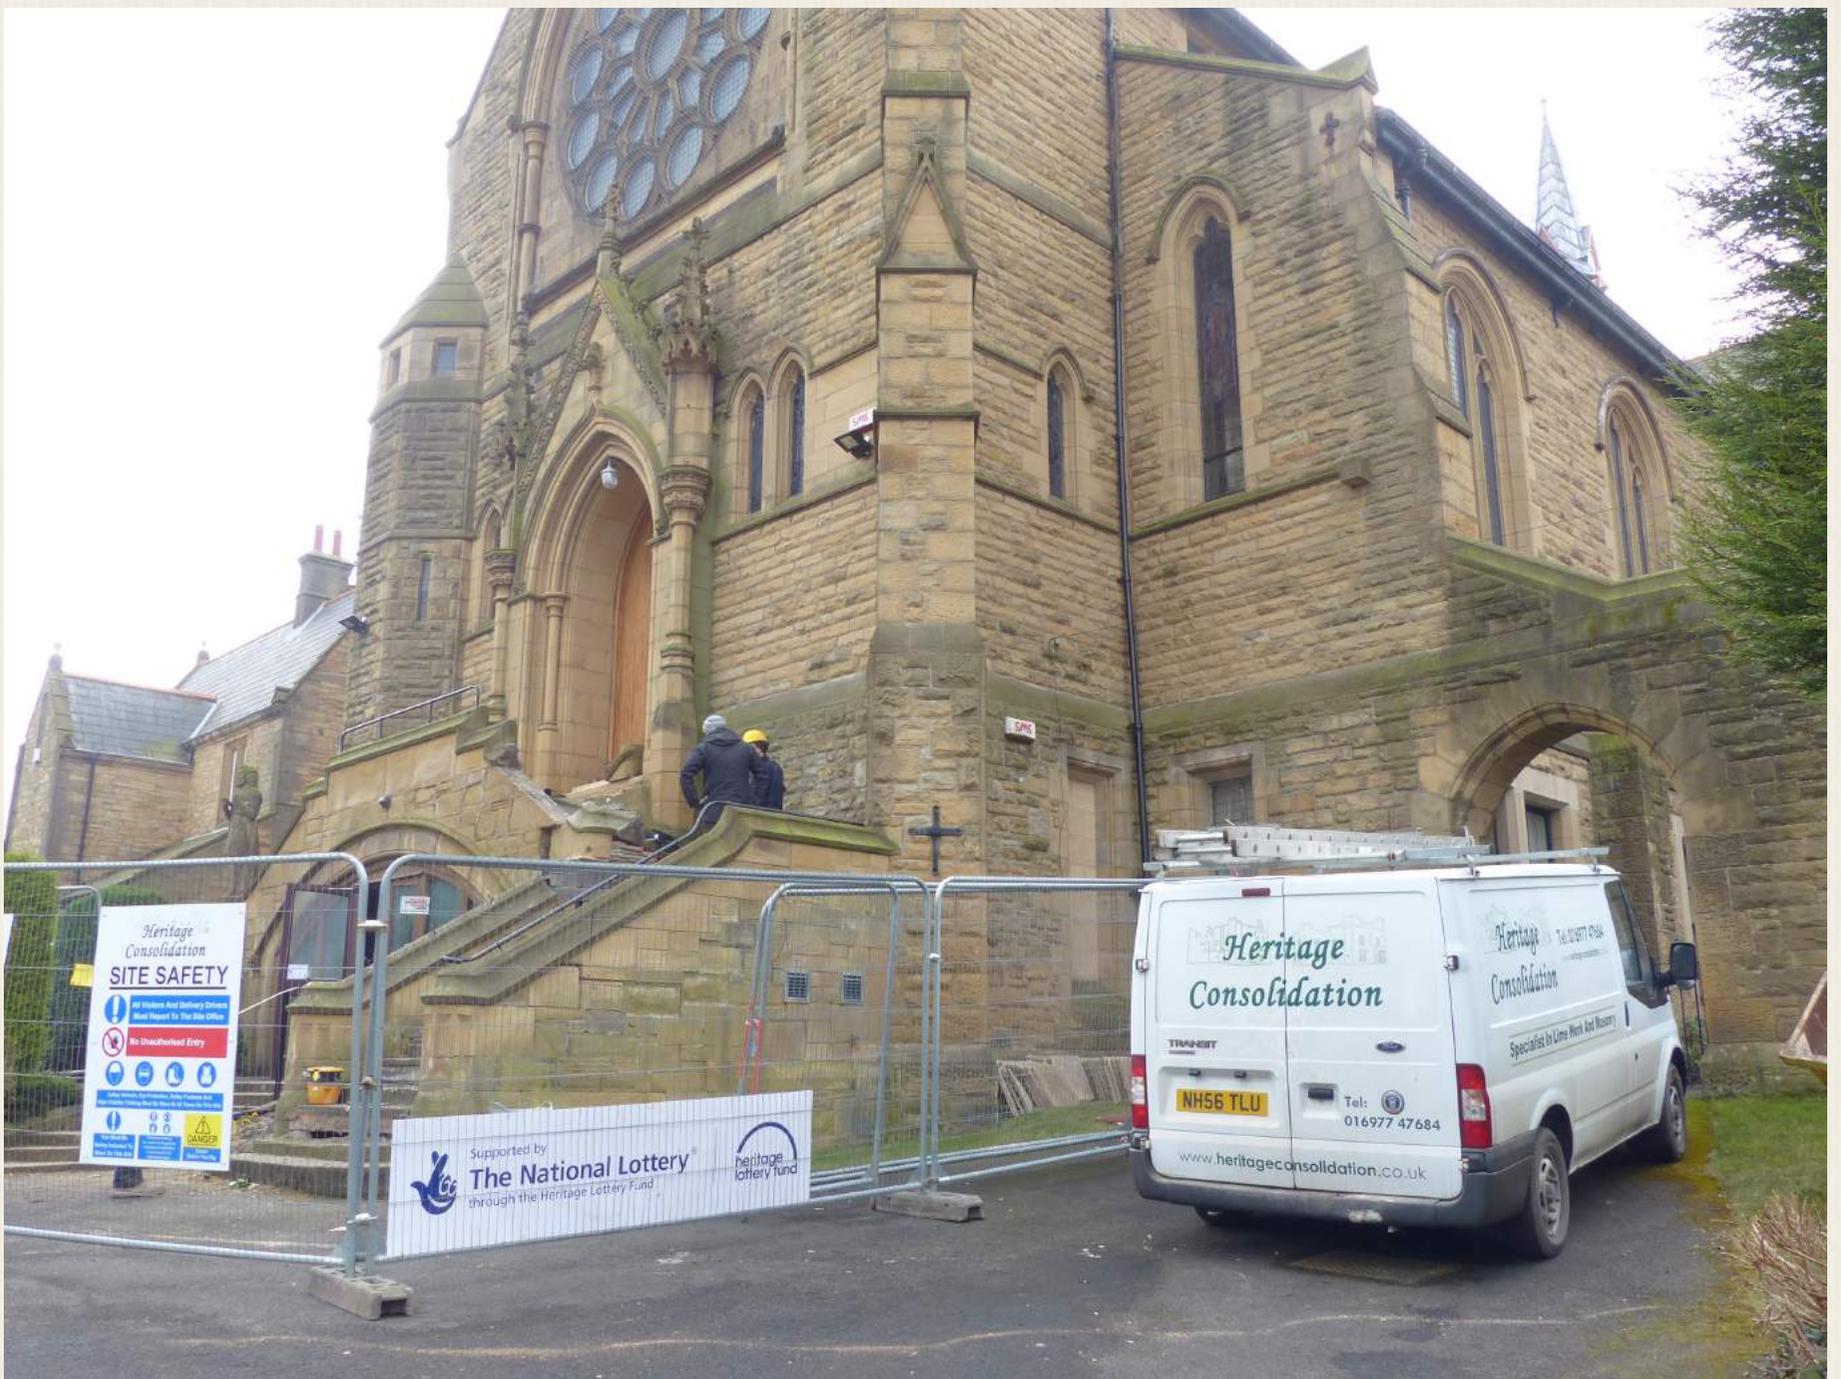
Work started on 9 February 2015. The main contractor, Heritage Consolidation Ltd, erected a security fence around the perimeter of the work site. This enabled pedestrian access to the Church via the emergency exit of the Parish Centre and ensured Church services were not affected.

Security fence around work site

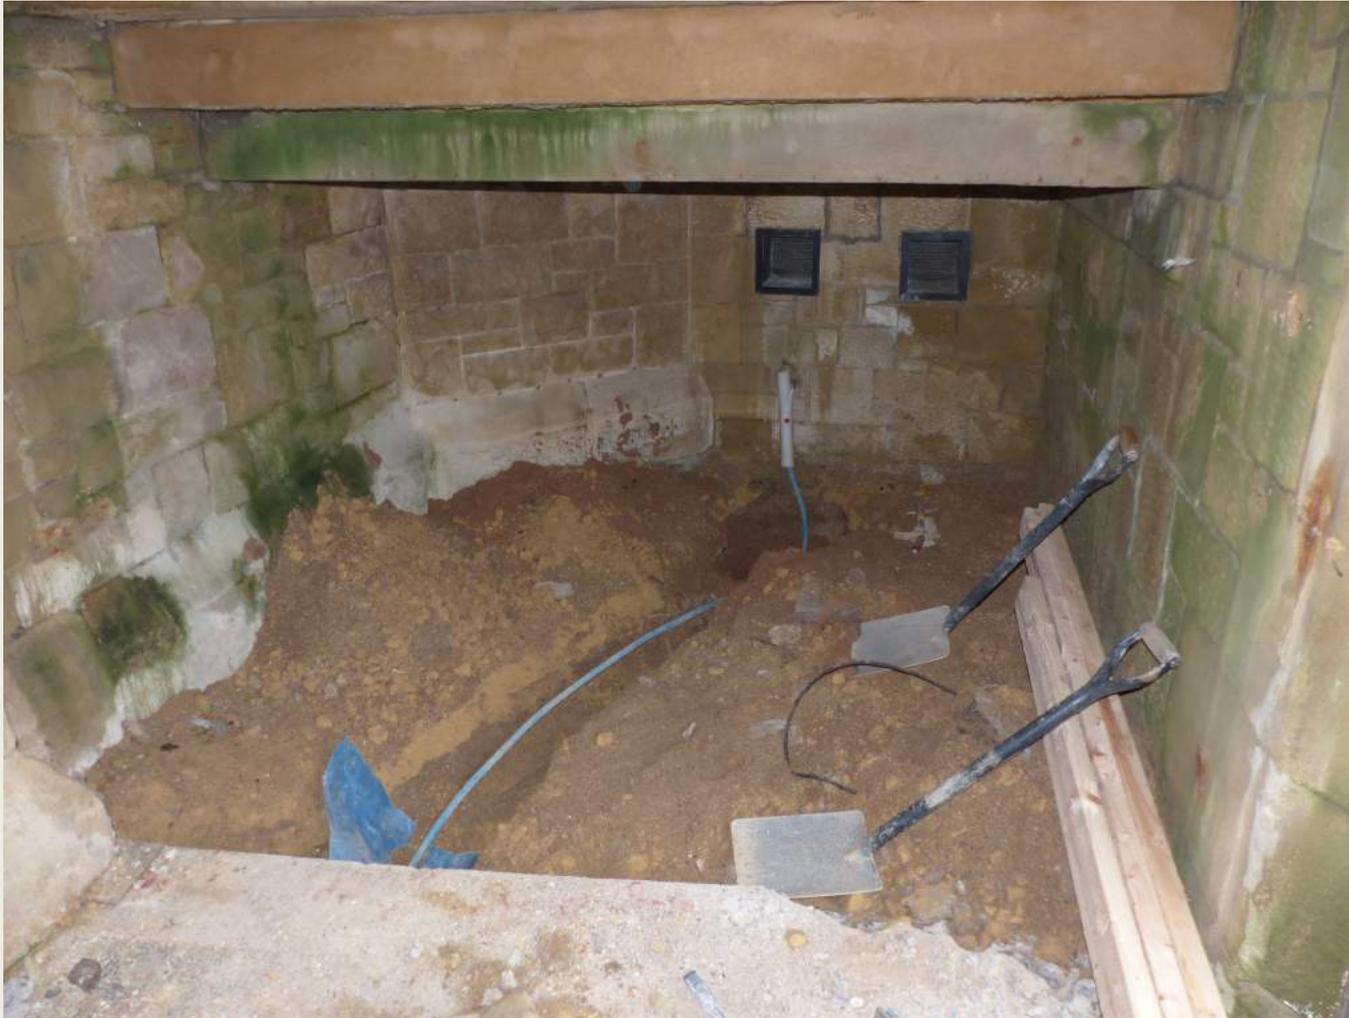
The floor of the lobby was removed and excavations prepared for foundations for the building of new retaining walls to support the steps on the upper level on both the east and west staircases.

Ground work within Parish Centre entrance

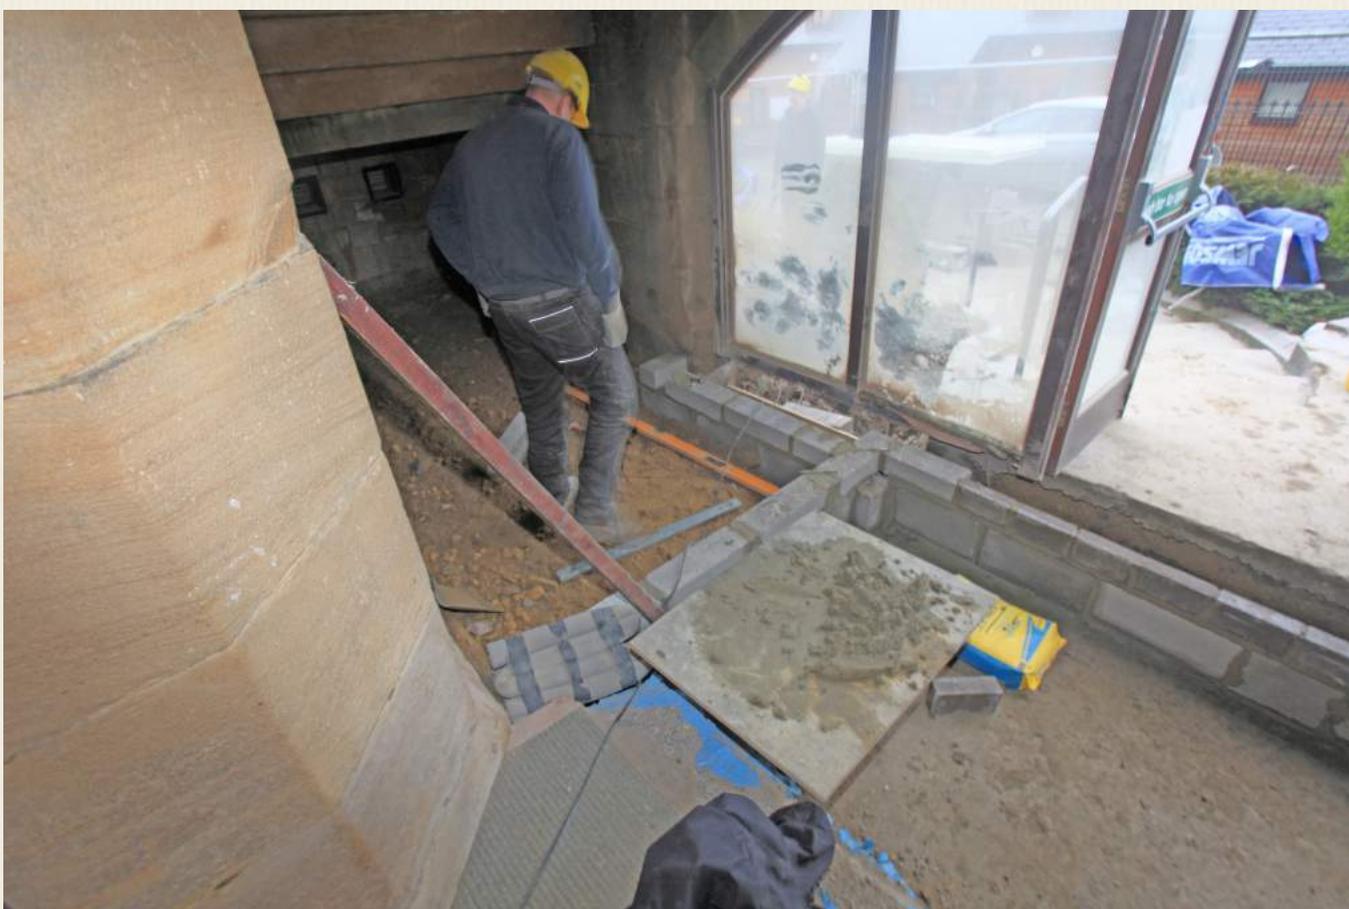
Supporting wall within Parish Centre entrance

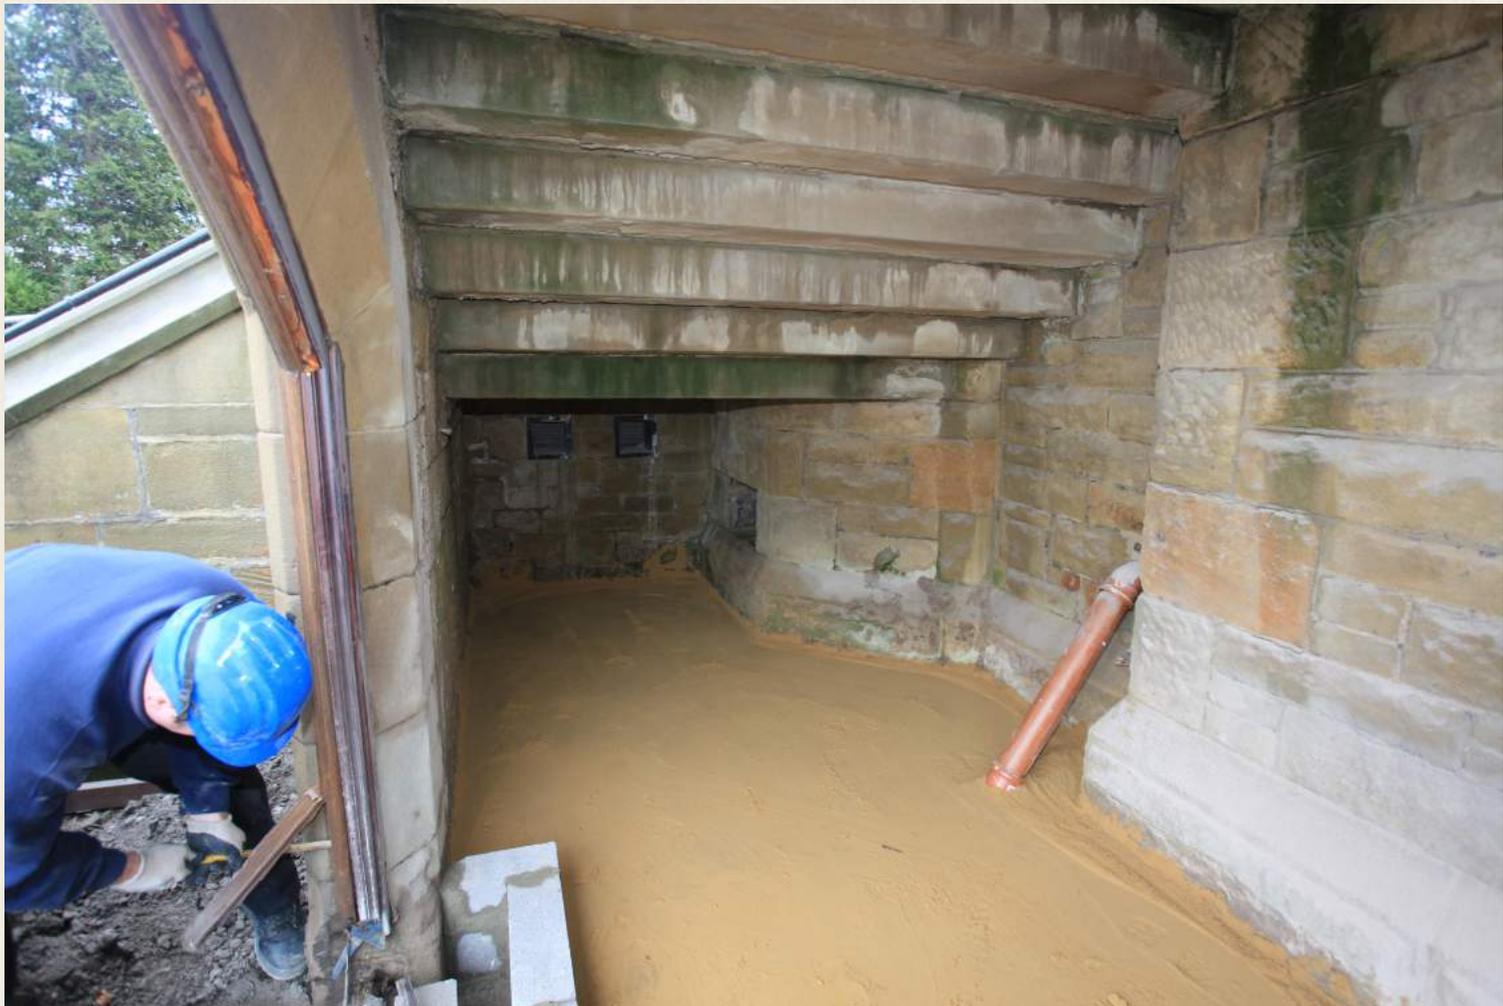
Compacted hard core under the east steps

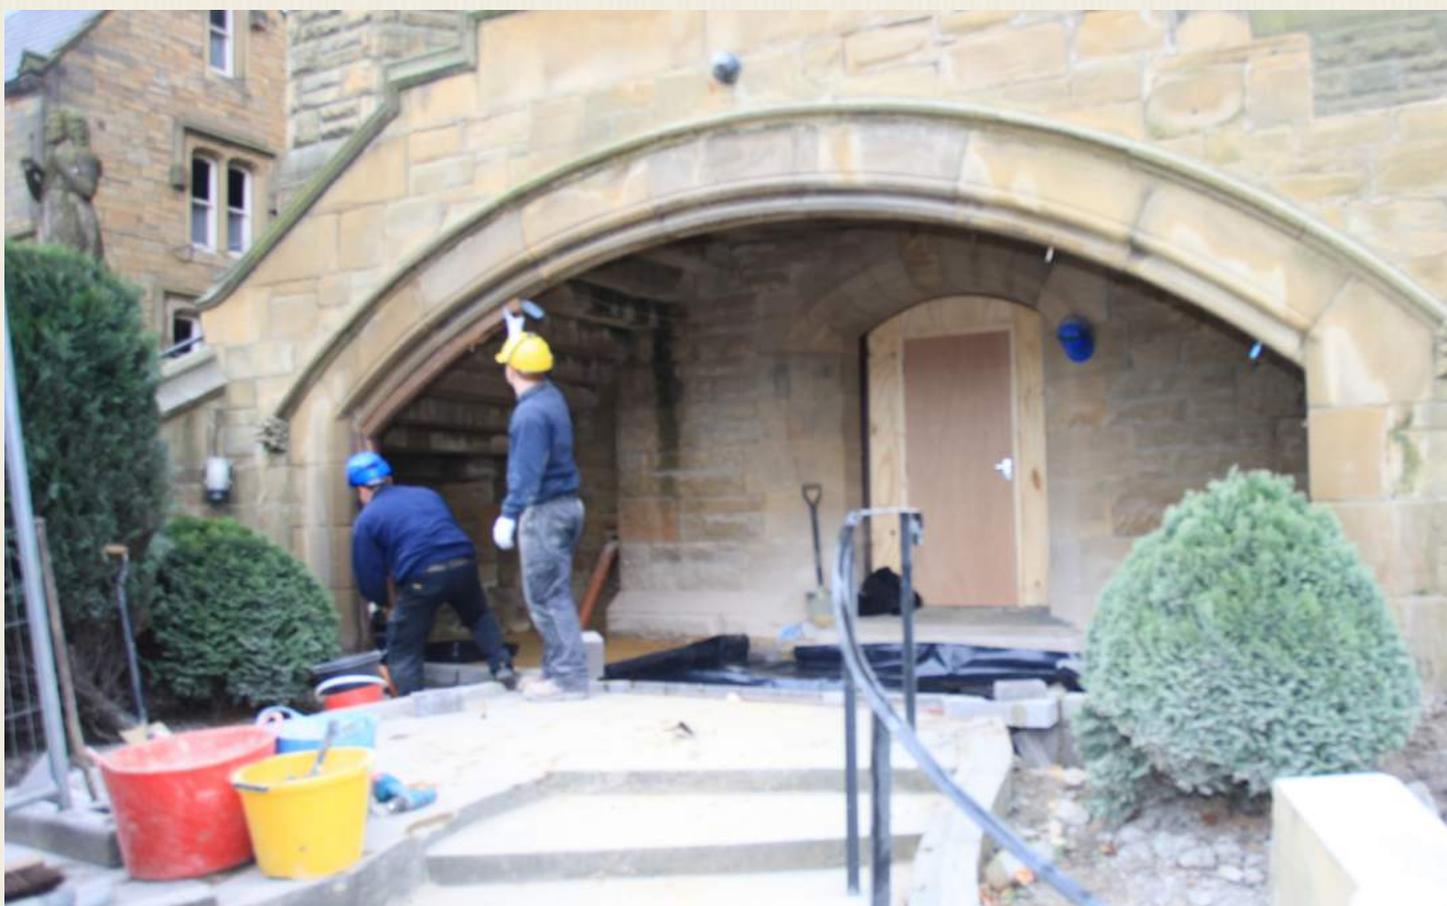
All internal partitioning at the entrance to the Parish Centre was removed together with the external timber-glazed screen. A temporary door was fitted inside the main body of the Church to retain security once the external timber-glazed screen was removed.

Removal of old framework to Parish Centre

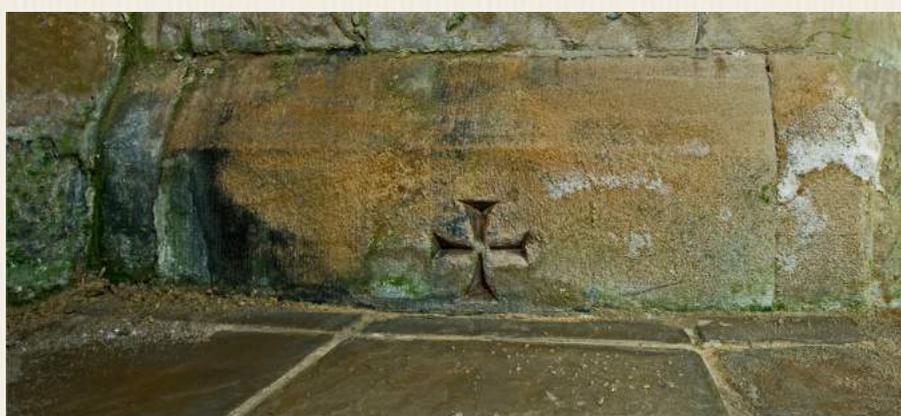
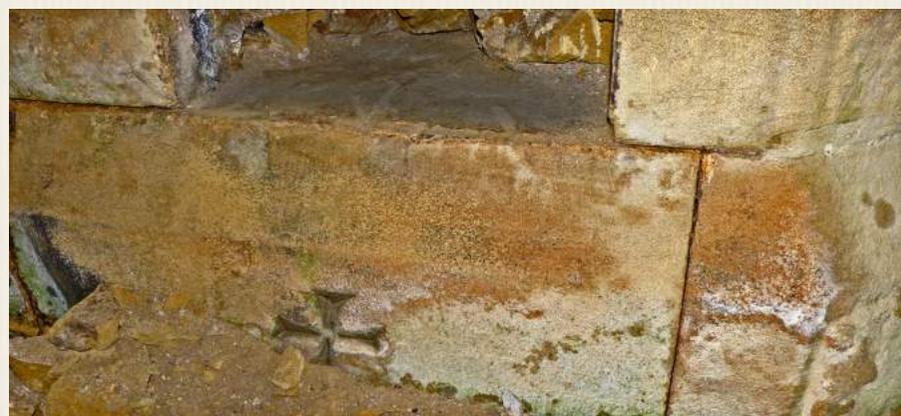
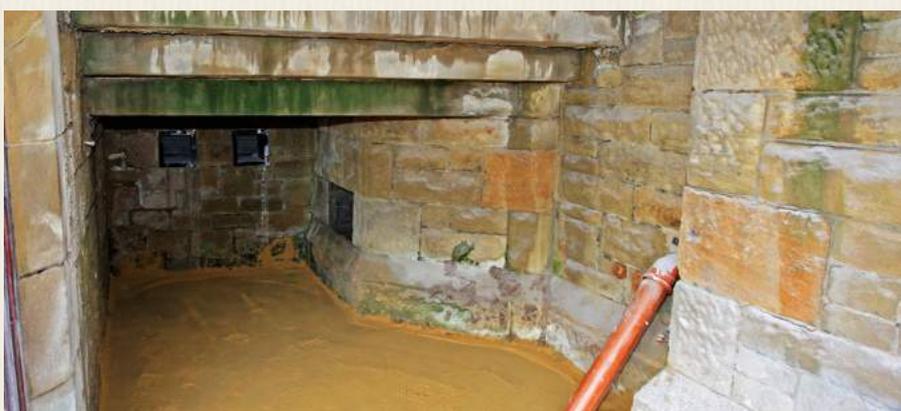
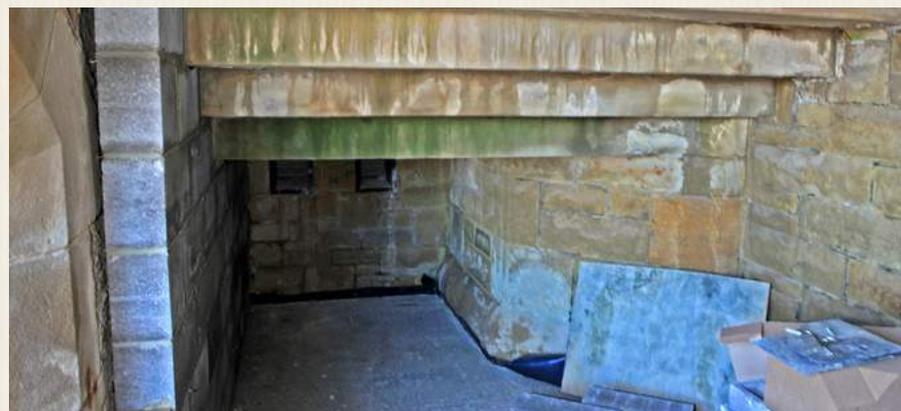
Foundation Stone record

The foundation stone, located beneath the mid landing of the east staircase was not immediately visible. When the renovation of the steps began it was the intention to reposition the stone to the outside of the west staircase. However, due to the physical size and weight of the stone this was not possible. Therefore, a photographic record was taken, this will be displayed in the entrance to the Parish Centre to serve as a permanent reminder of the shape and location of the foundation stone which is now concealed behind the supportive wall of the east staircase.

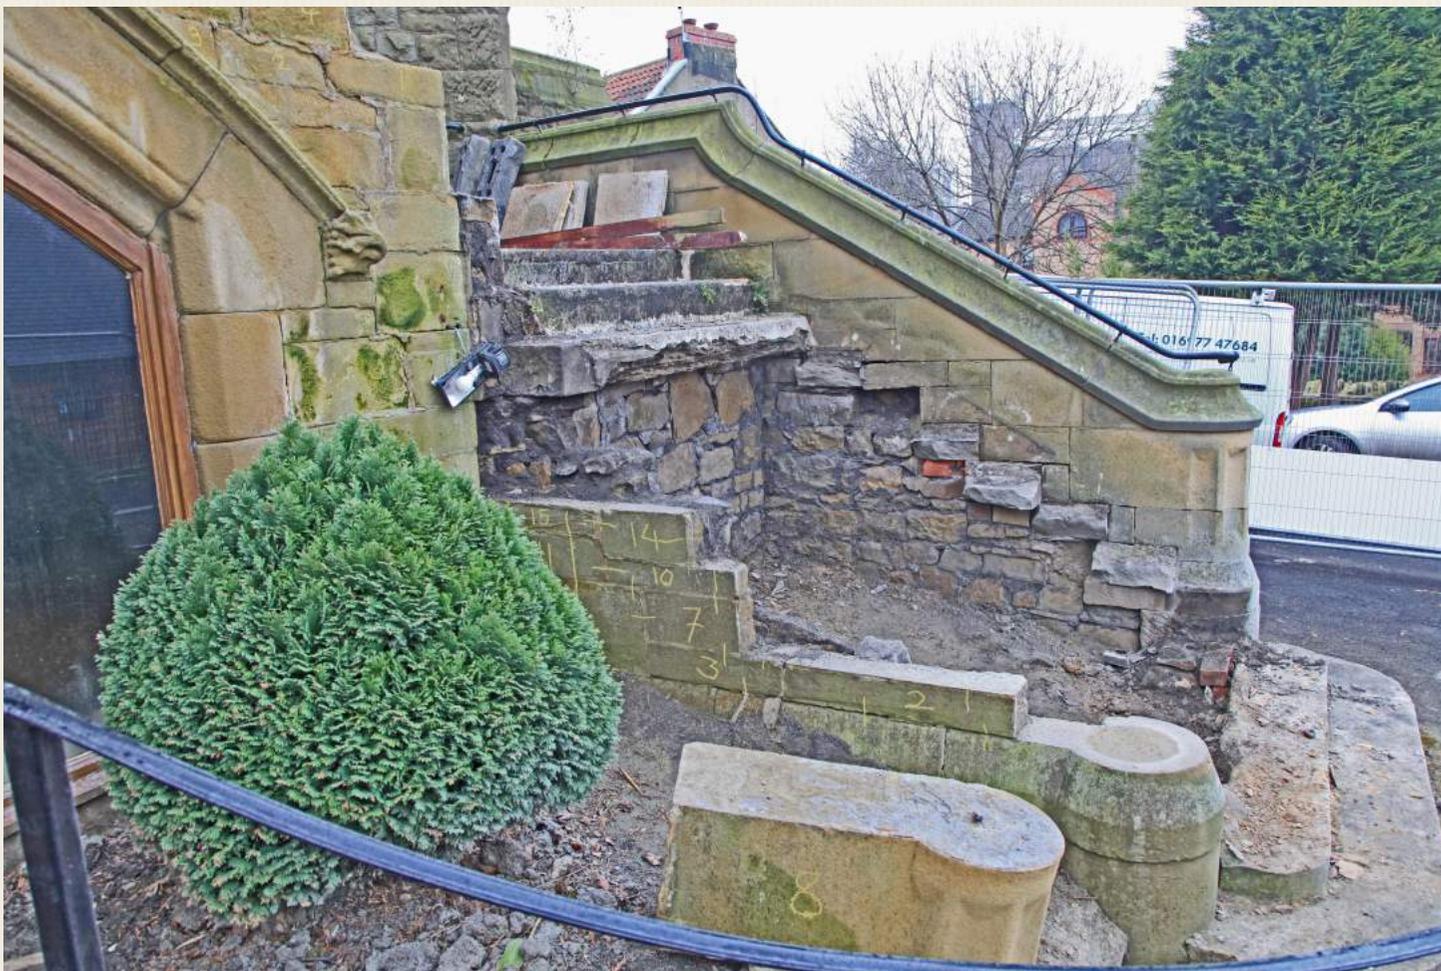
The existing ashlar stones on the retaining wall on the left hand side of the north west staircase were numbered prior to removal so that they could be repositioned in their original position once the renovation had been completed.

Stones numbered on west staircase

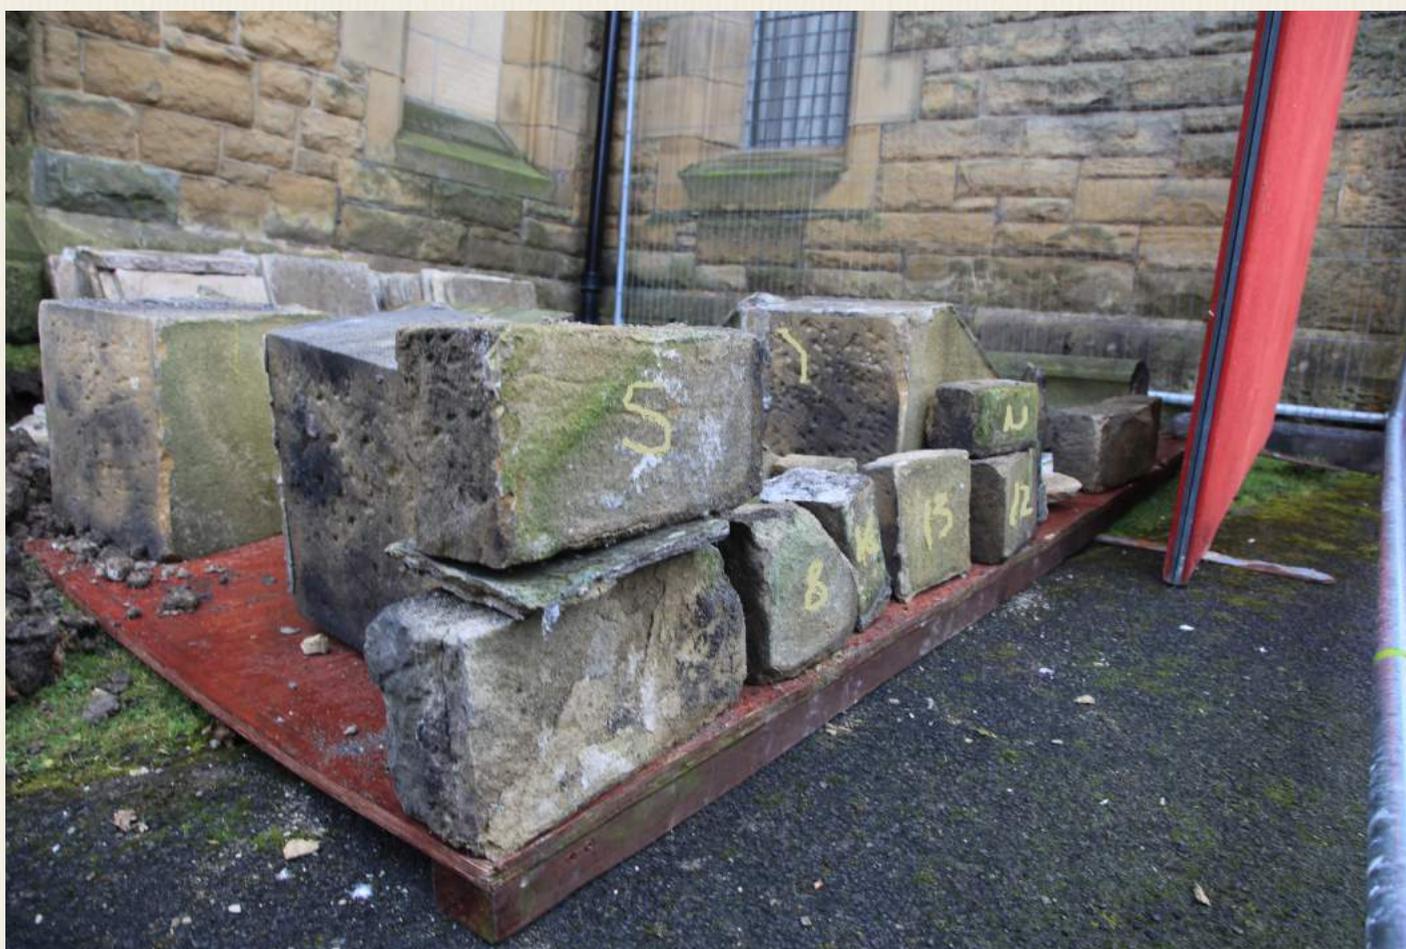
Storage of stones from west staircase

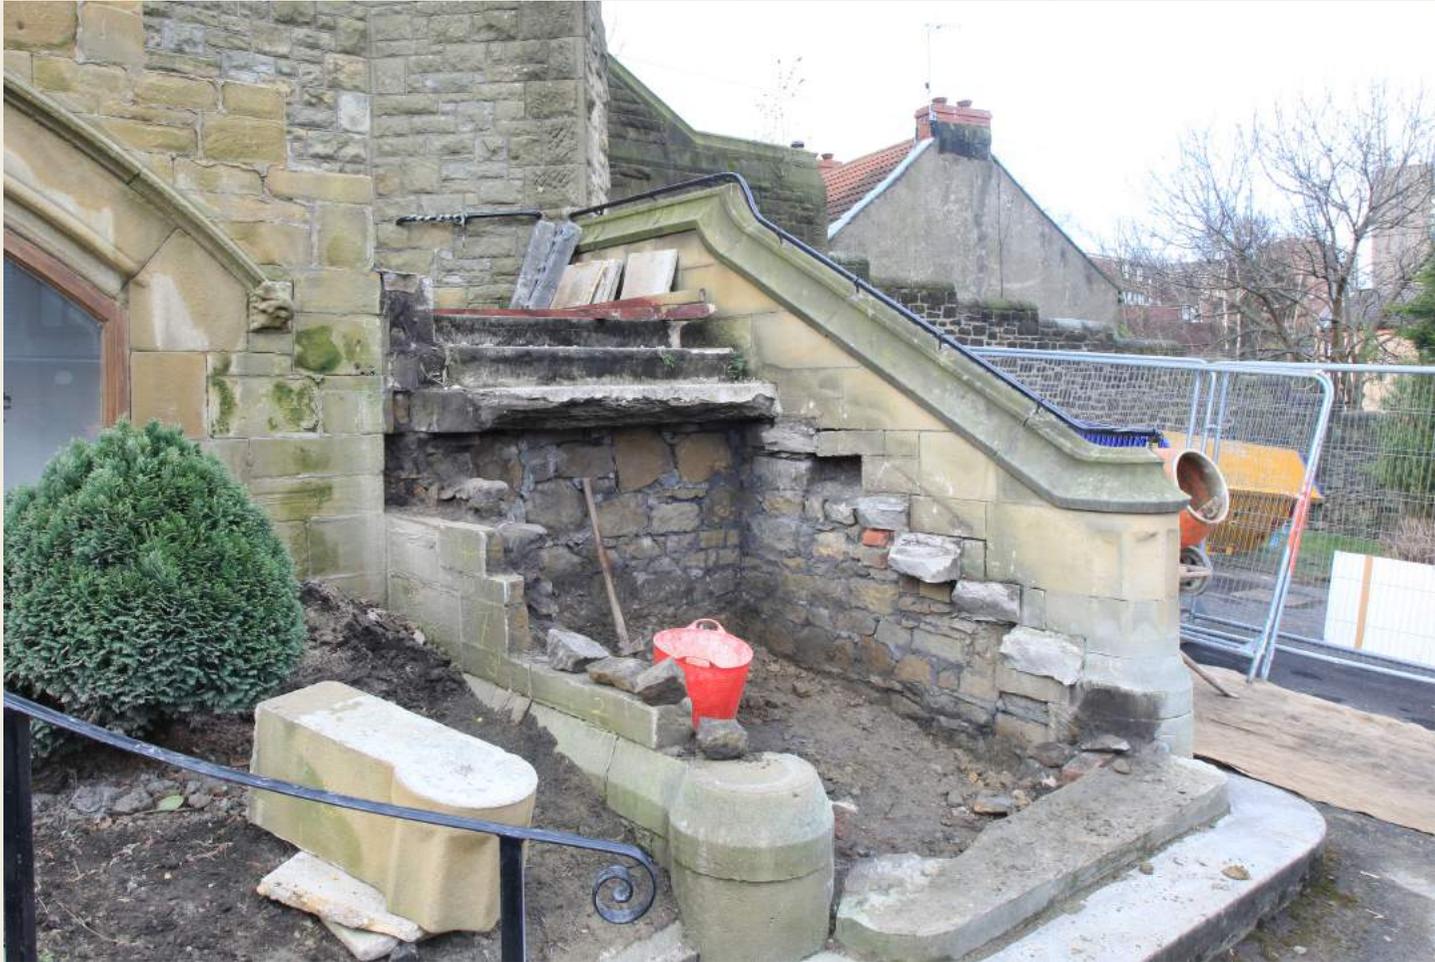
Stones and steps removed from west staircase

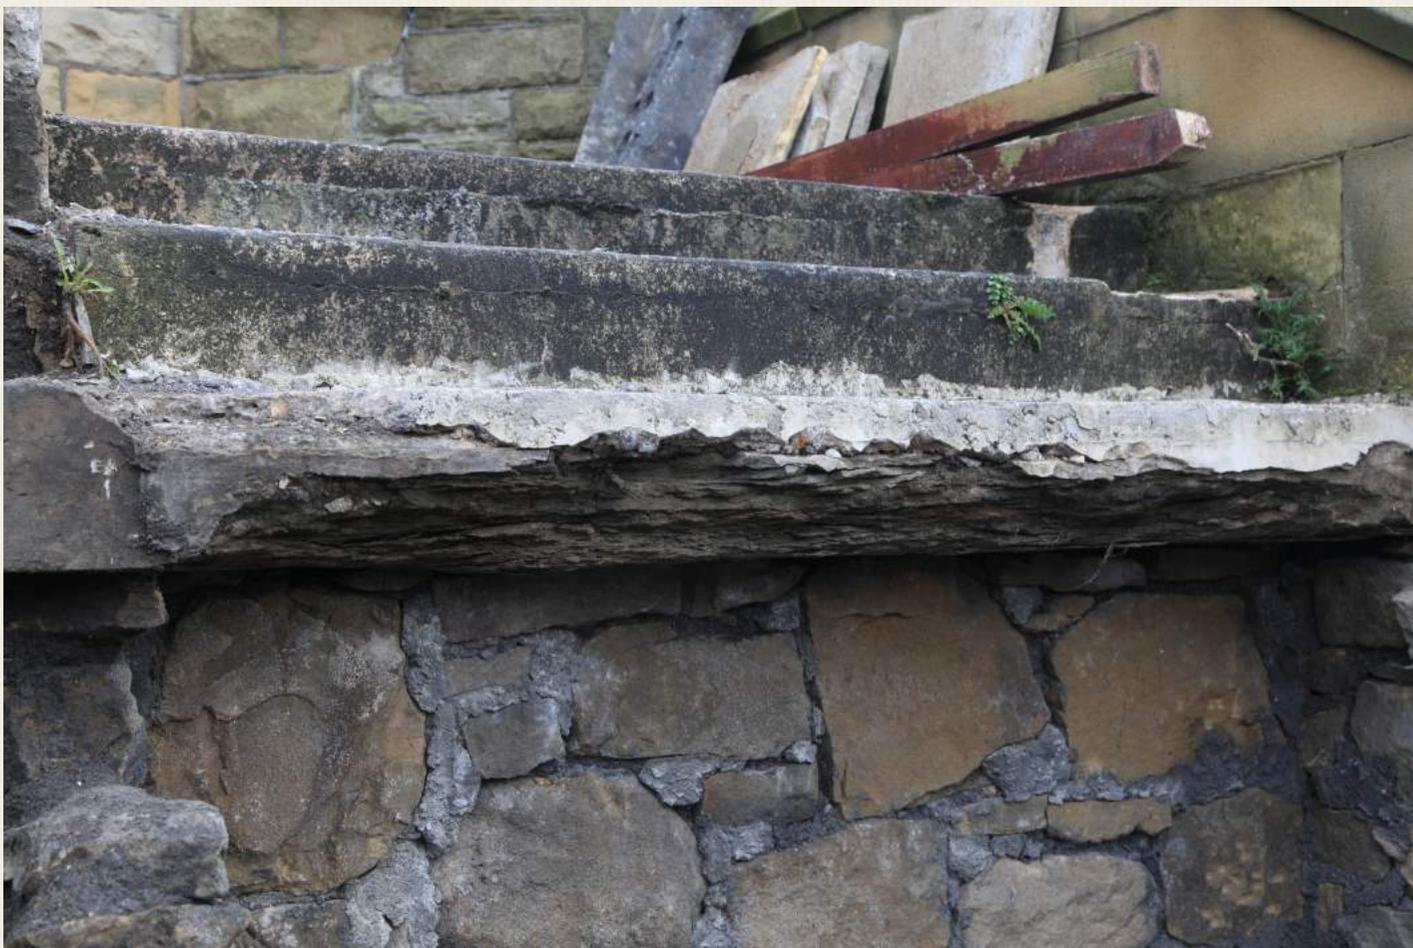
During the removal of the lower flight of steps one of them disintegrated because of flaws in the material known as strata.

Strata in one of the steps

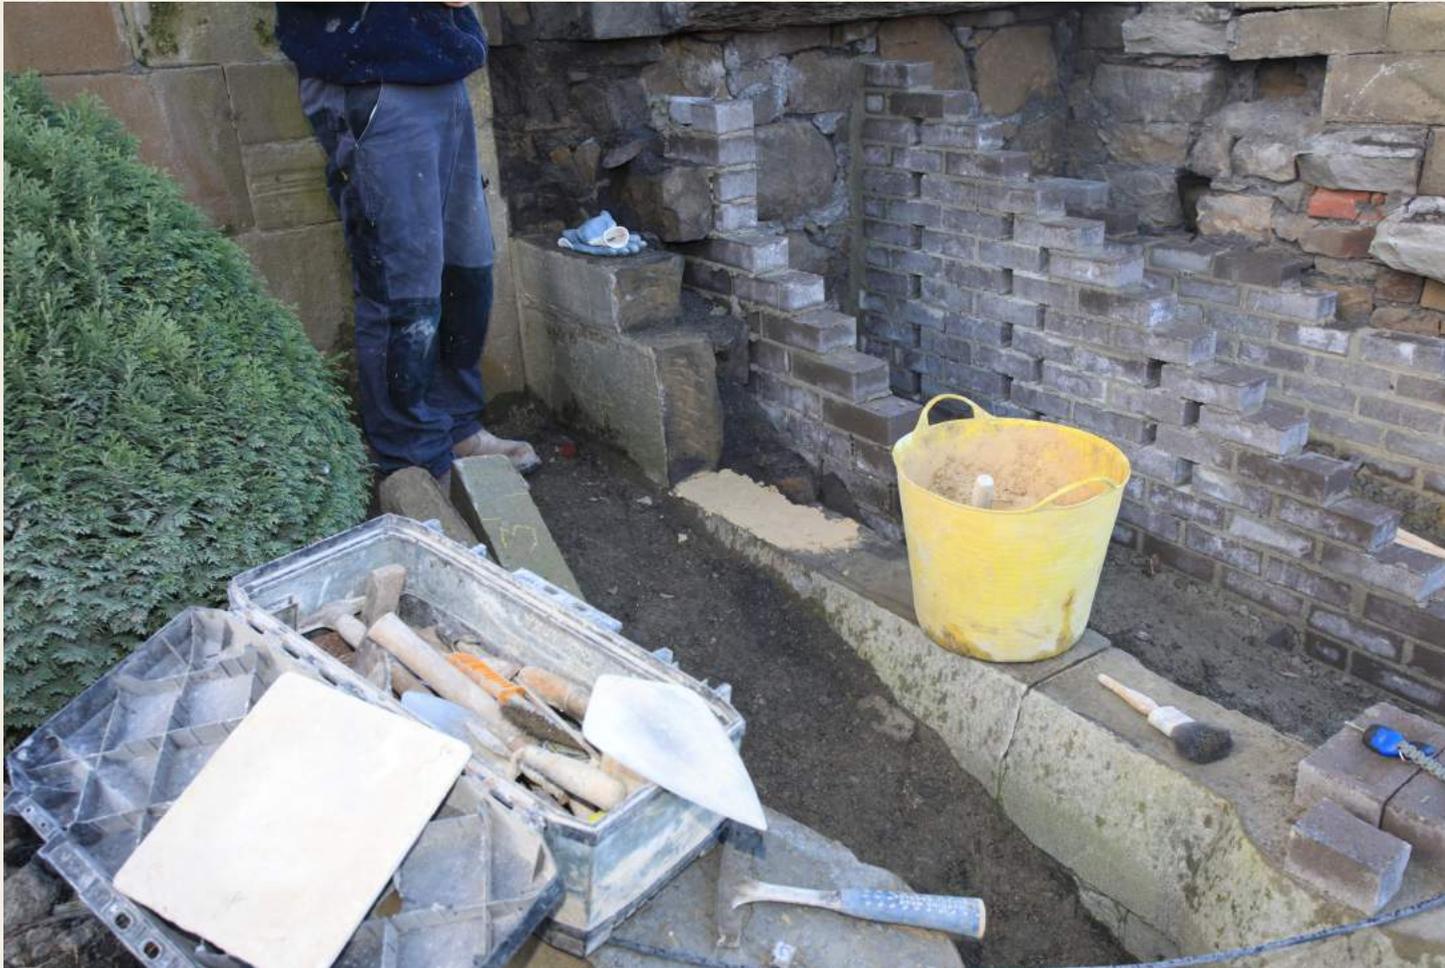
New retaining walls were built to support the lower and upper steps on the north west staircase and the upper section of the north east staircase.

New retaining wall on west staircase

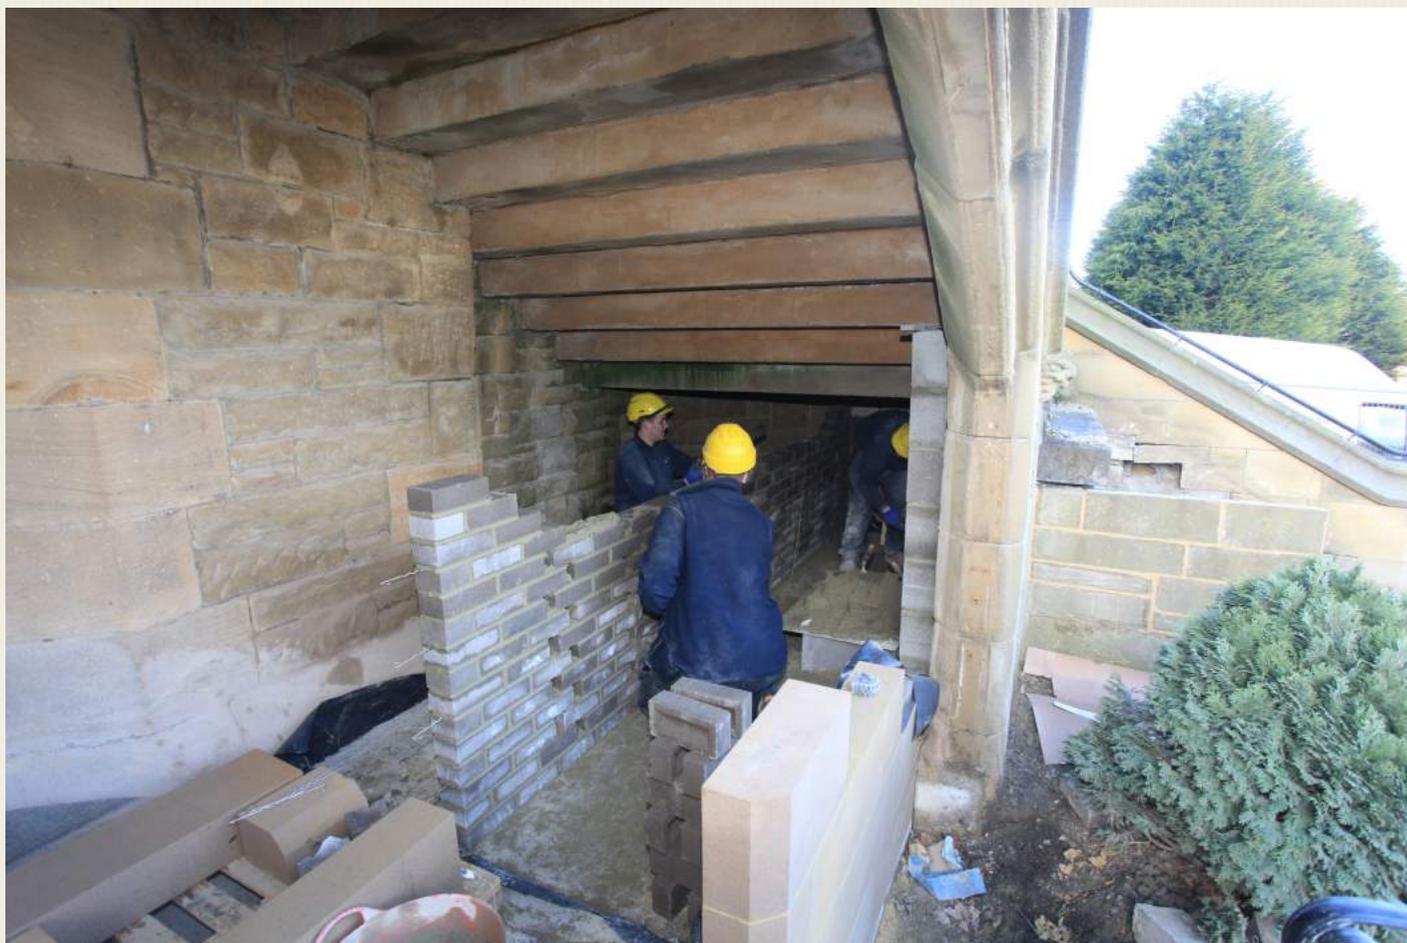
New retaining wall inside the Parish Centre entrance

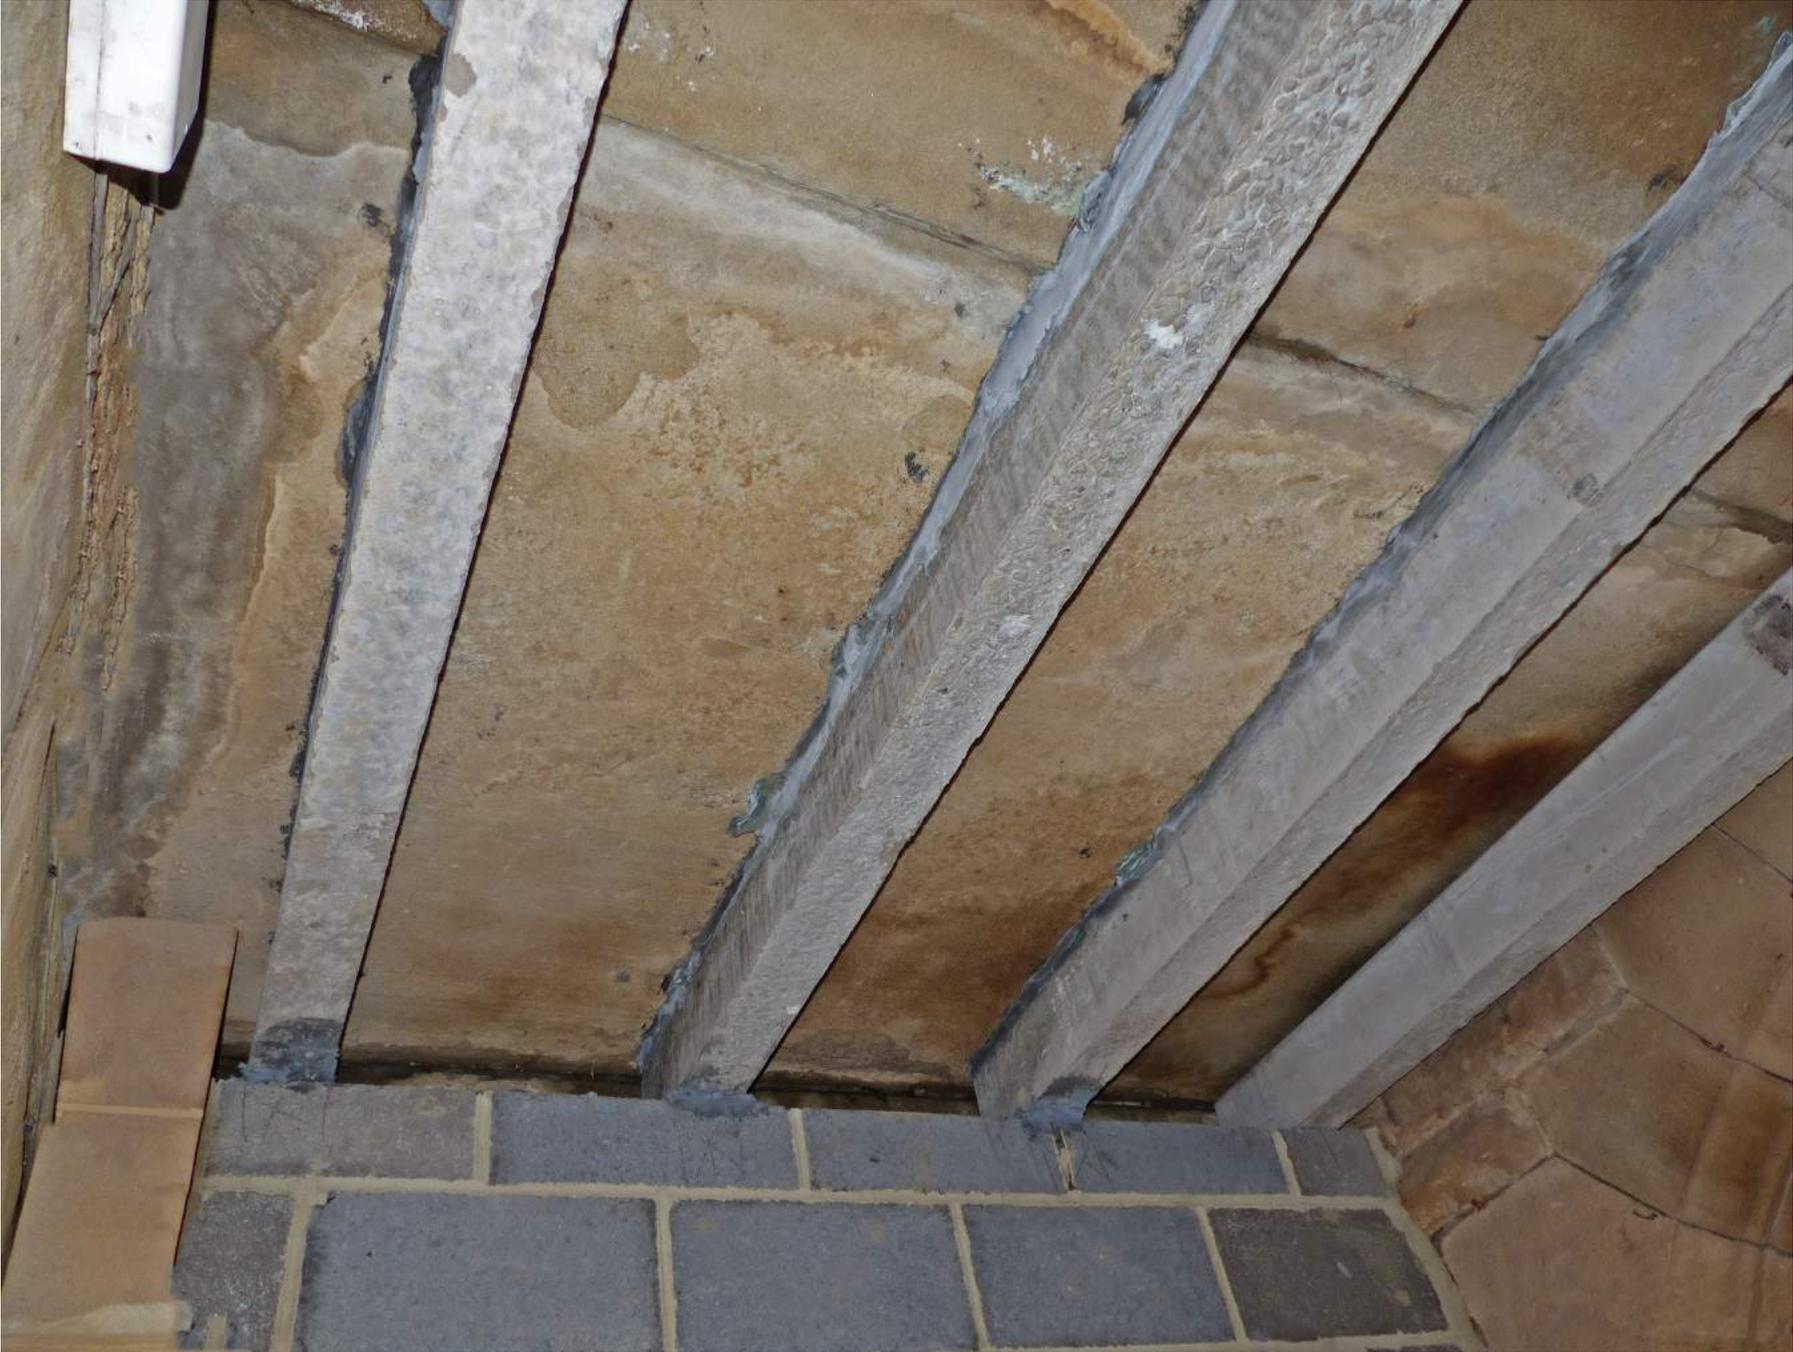
Concrete lintels were also inserted into the brickwork to assist in supporting the upper landing.

Concrete lintels inserted into retaining wall brickwork

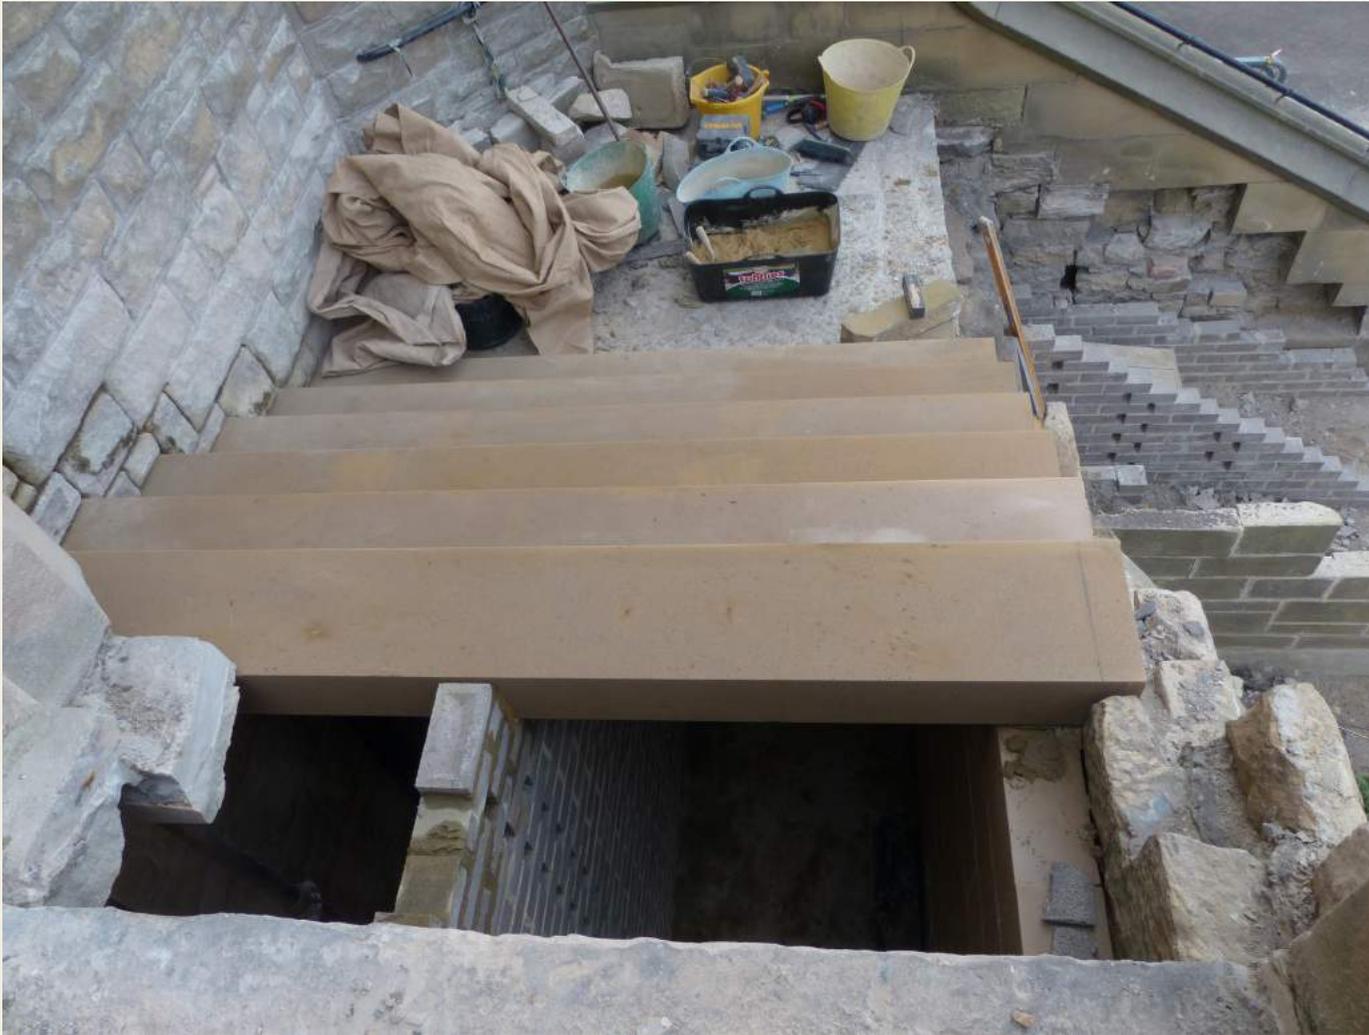
New steps were inserted into the existing stonework on the upper and lower landings of the north west staircase.

New steps on upper flight on west staircase
