St. Patrick's RC Church, Felling **Revisited - 2015**

In 2014 St. Patrick's RC Church, Felling was awarded a grant of almost £90,000 from The Heritage Lottery Fund to renovate the steps leading up to the processional entrance of the Church. These steps had deteriorated to such an extent that they were deemed unsafe.

This edition is a pictorial record of the work carried out during the renovation and is a sequel to "The History of St. Patrick's RC Church, Felling 1895 - 2014" which covers the history of Catholicism in Felling and in particular the history of St. Patrick's Parish.

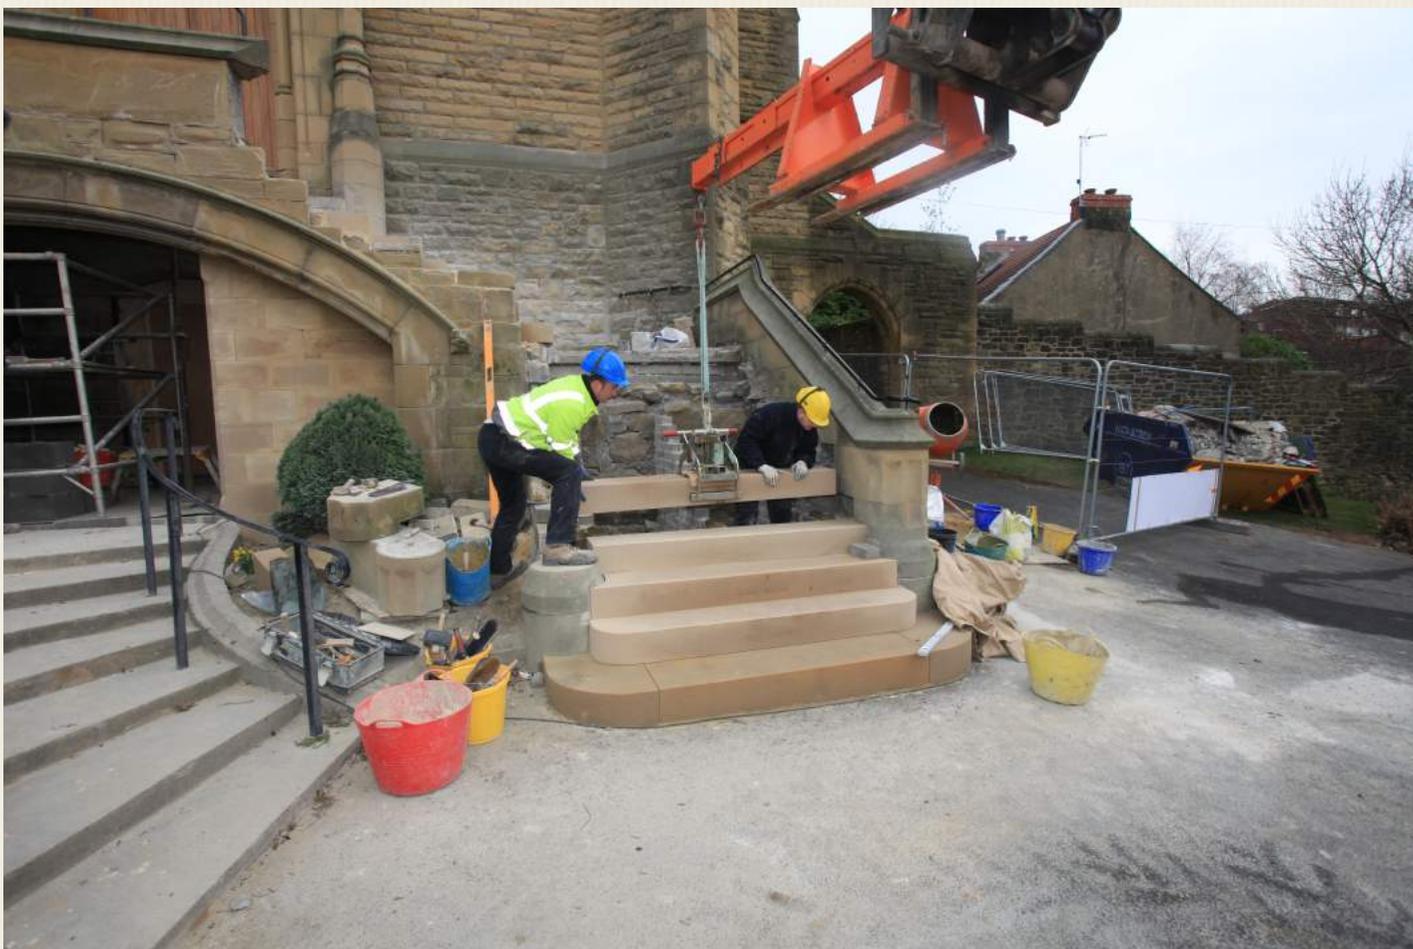
New steps on lower flight on west staircase

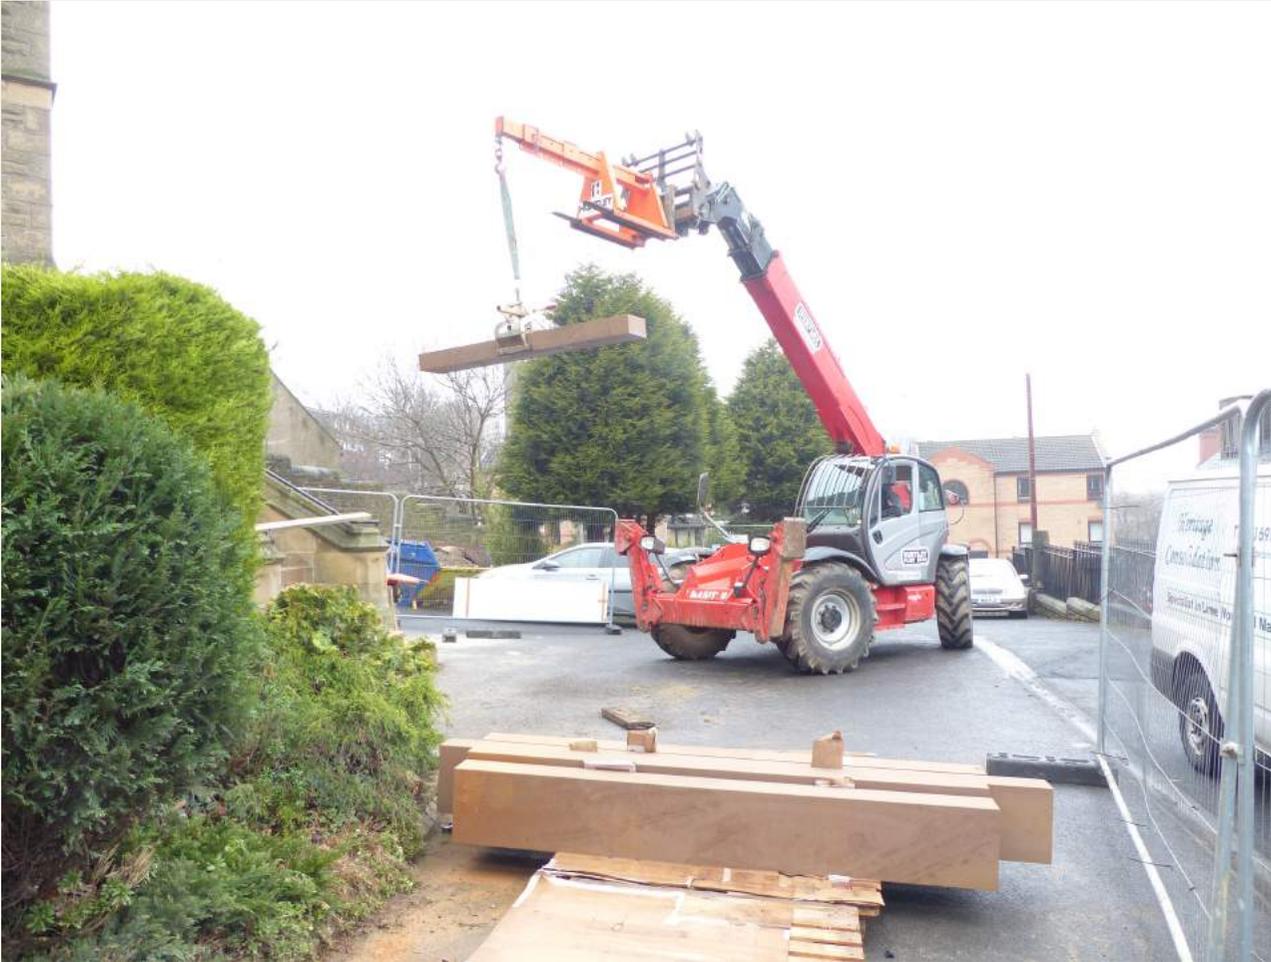
New steps were inserted into the stonework immediately adjacent to the processional entrance.

New steps being lifted

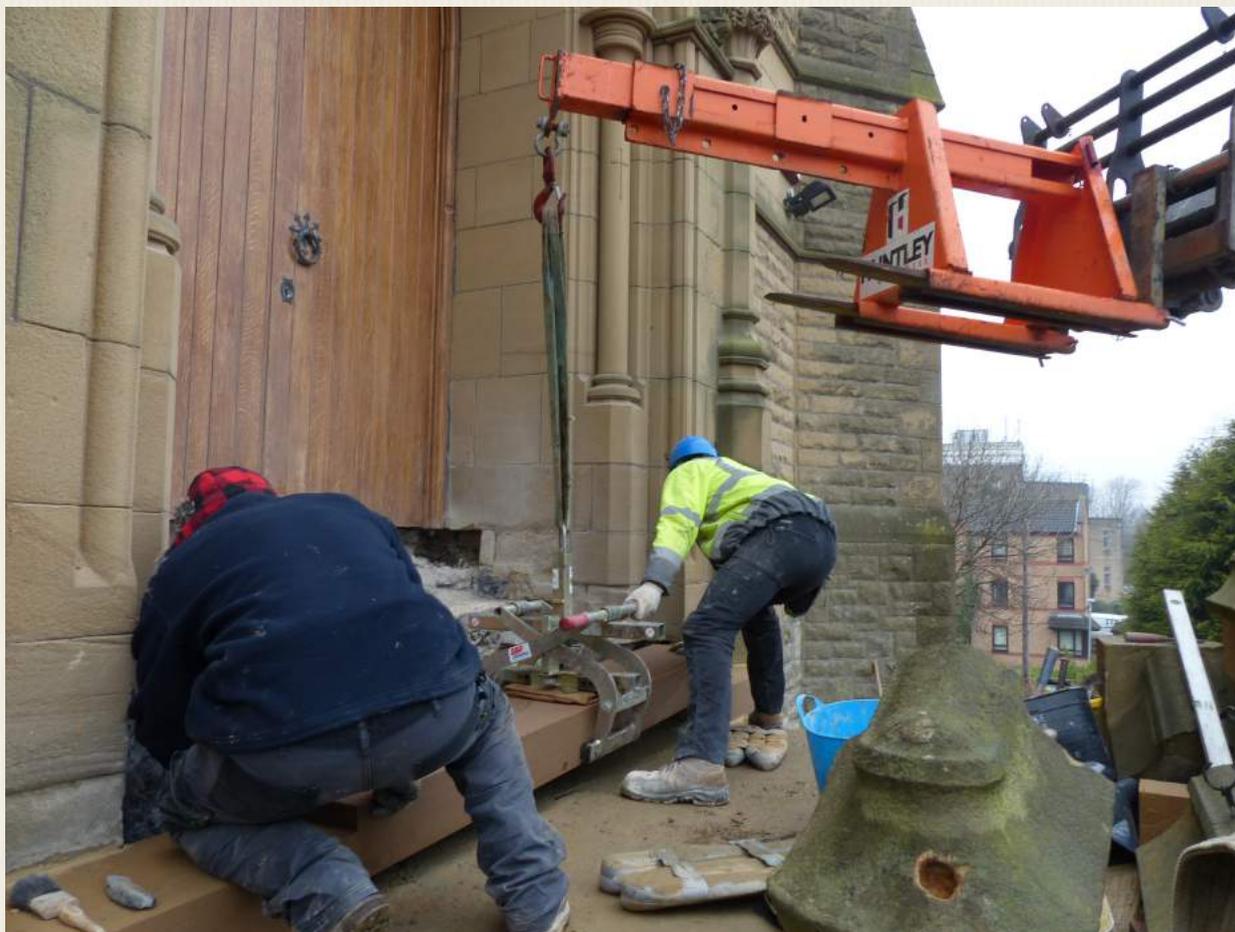
New steps being fitted at Church entrance

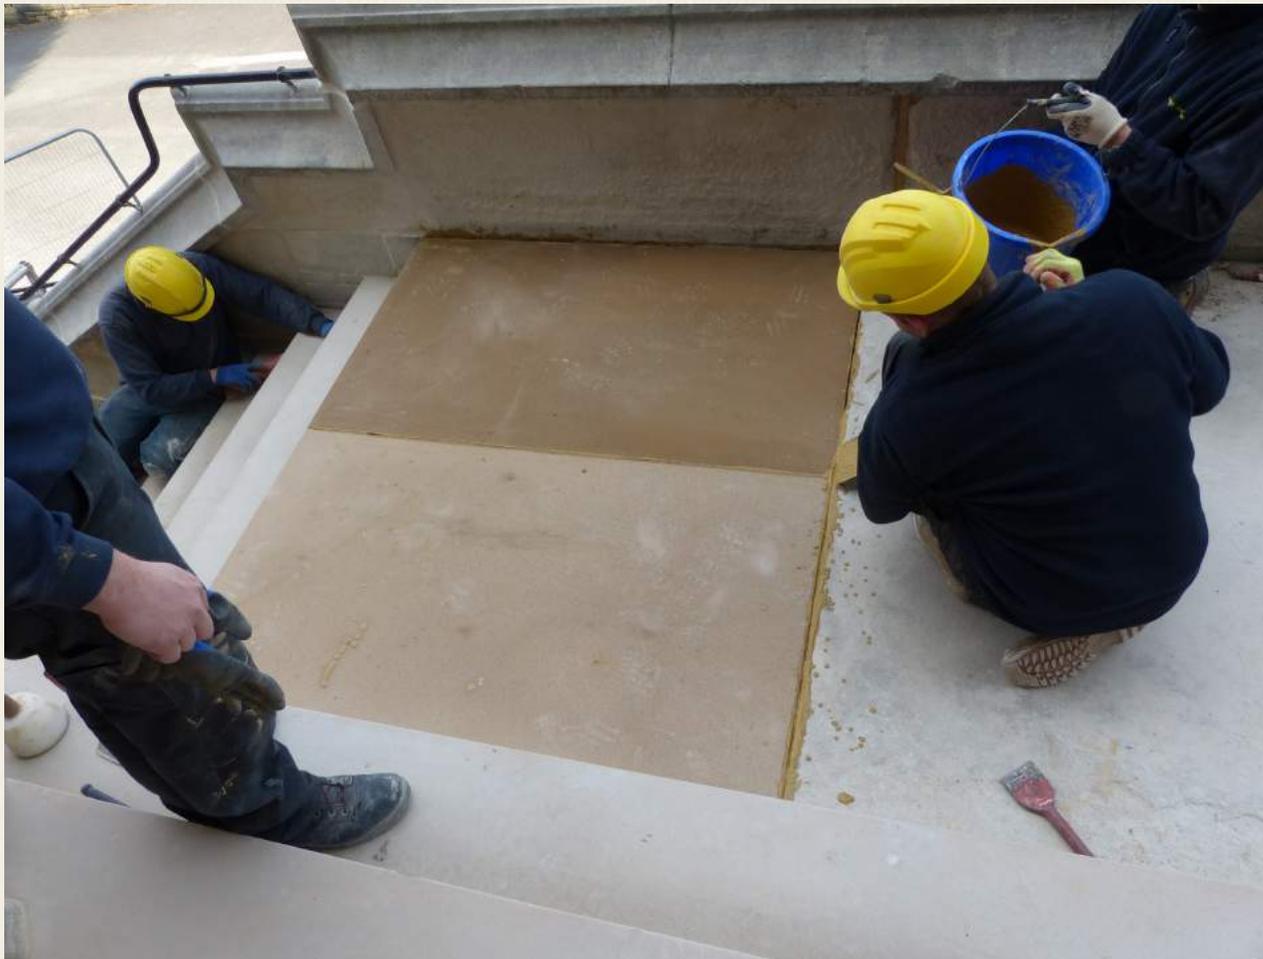
The reinforced slurry mix, used to repair the north west mid landing and the upper landing in the 1990s, had to be removed to expose the original stonework and allow the placement of new indents.

Sealing of new indents on upper landing

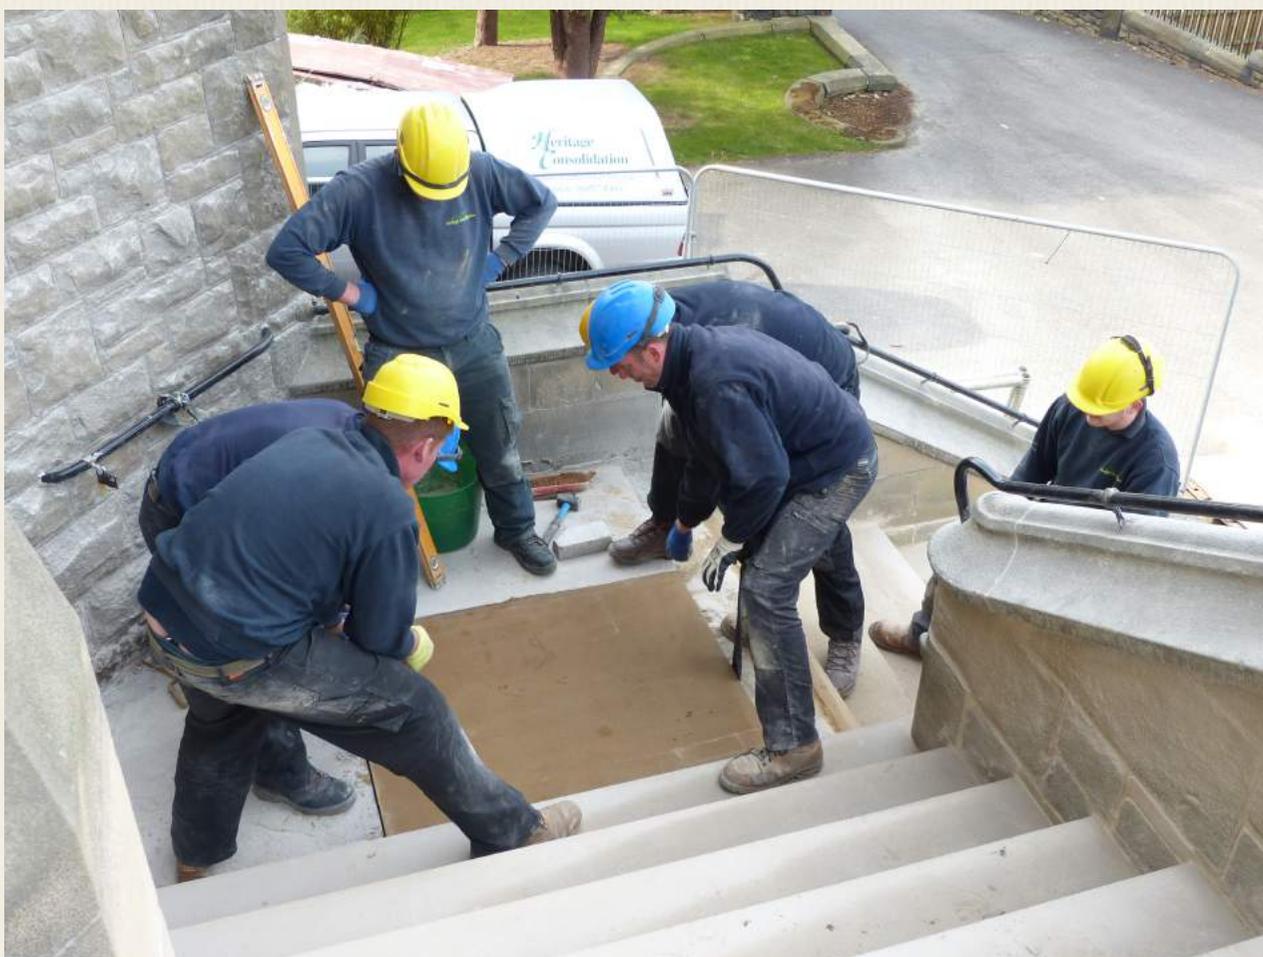
Fitting of new indents on intermediate landing

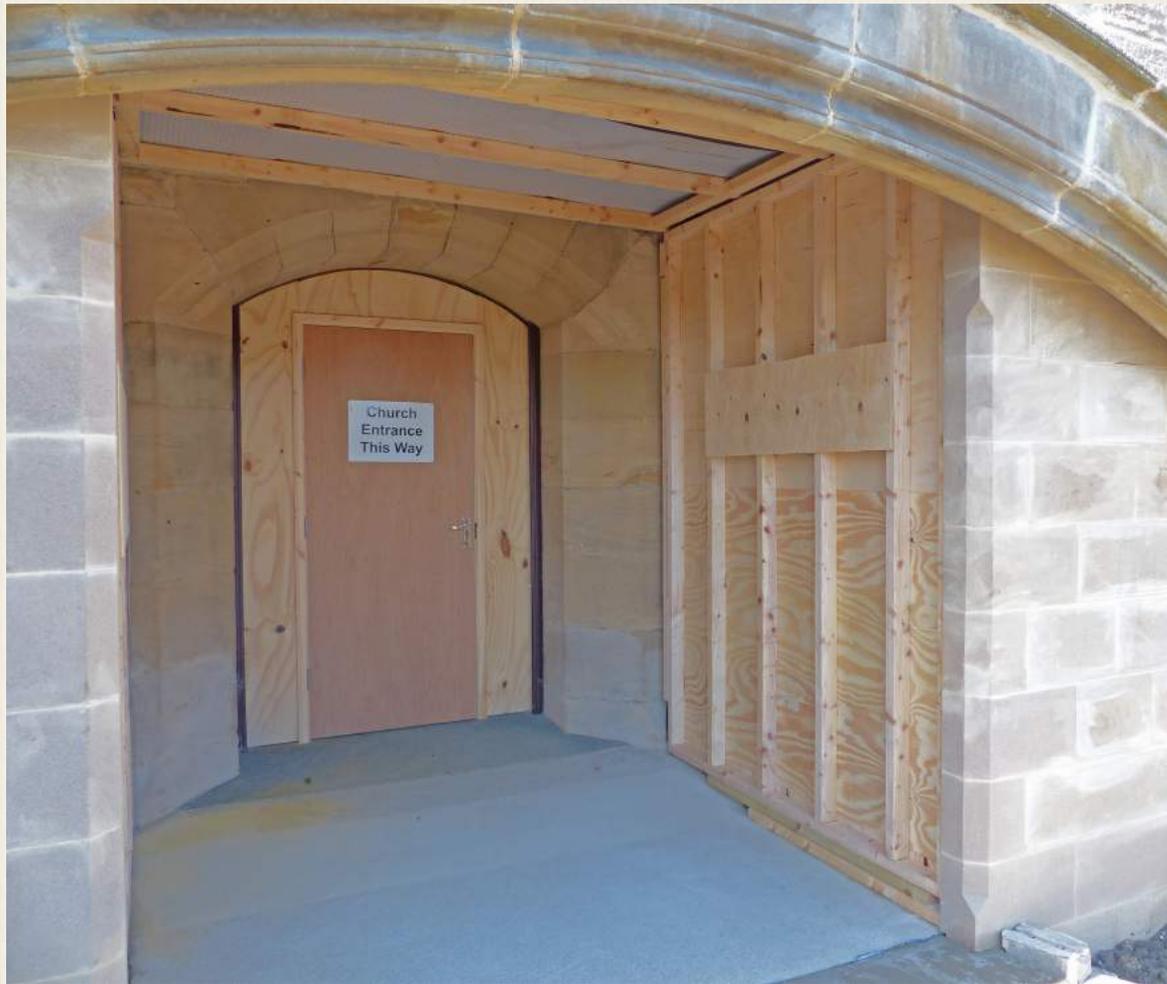
The inside of the Parish Centre entrance was boarded and a weatherproof membrane added to ensure that the entrance would remain dry.

Boarding on Parish Centre retaining wall

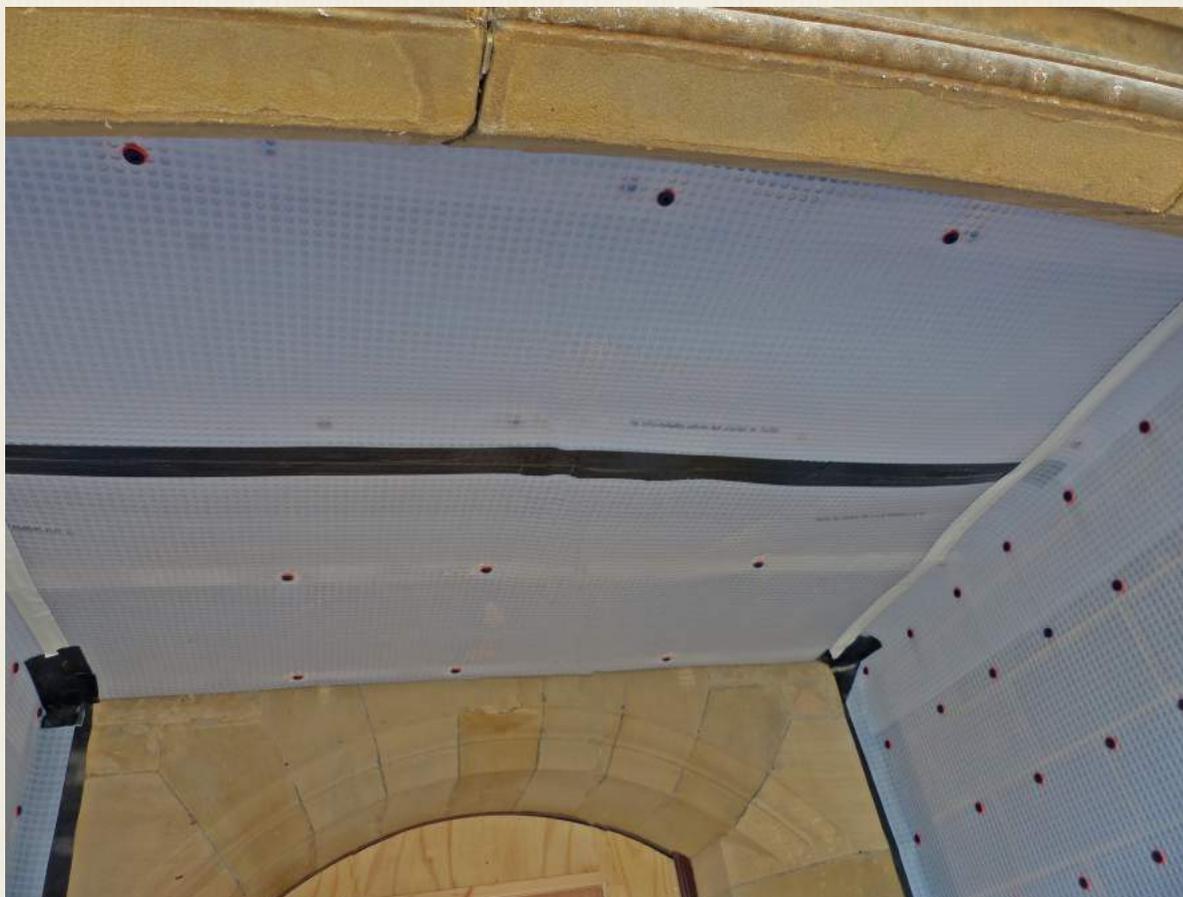
Waterproof membrane

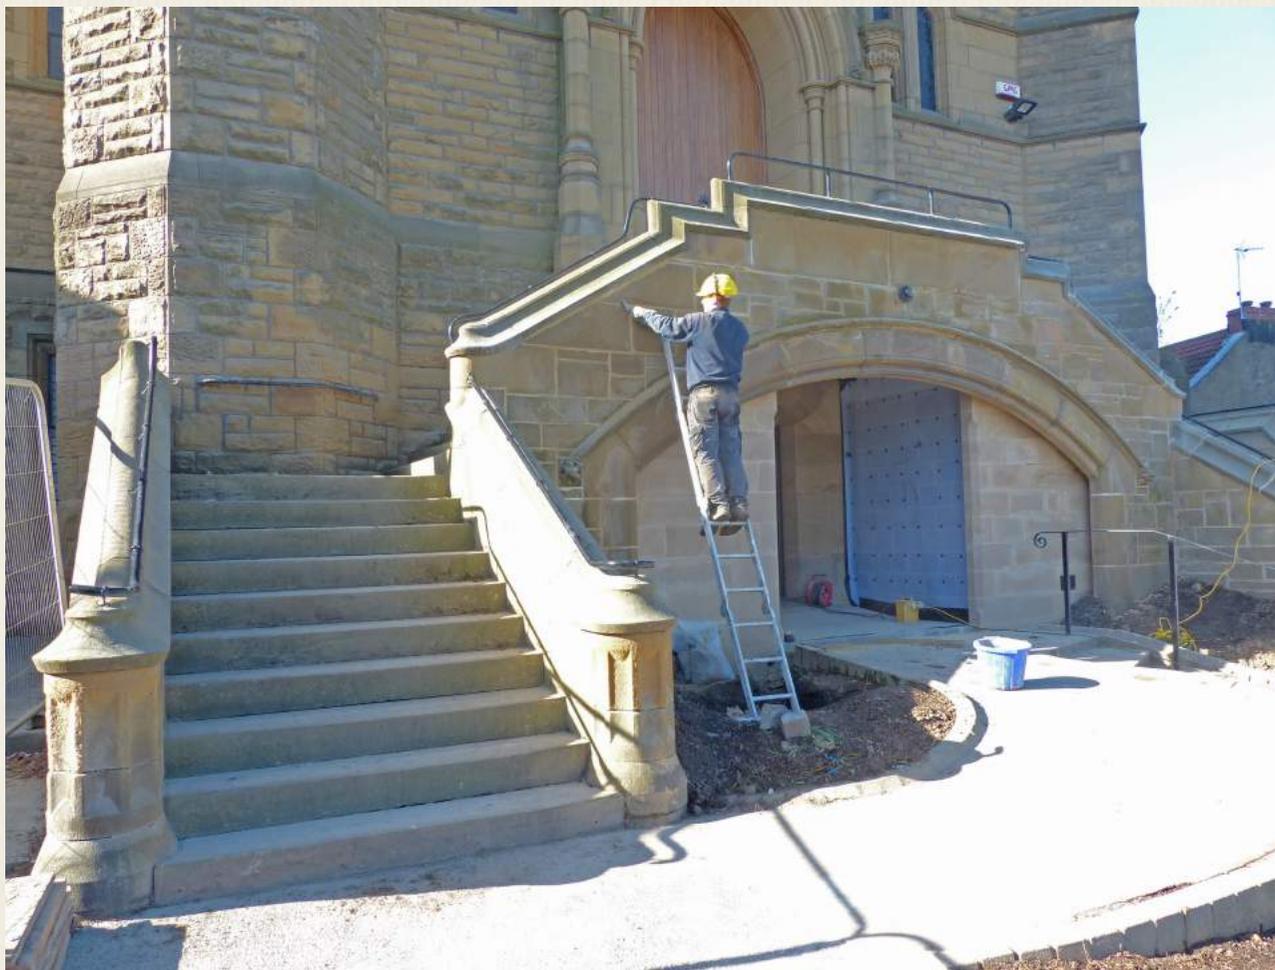
Repointing existing stonework

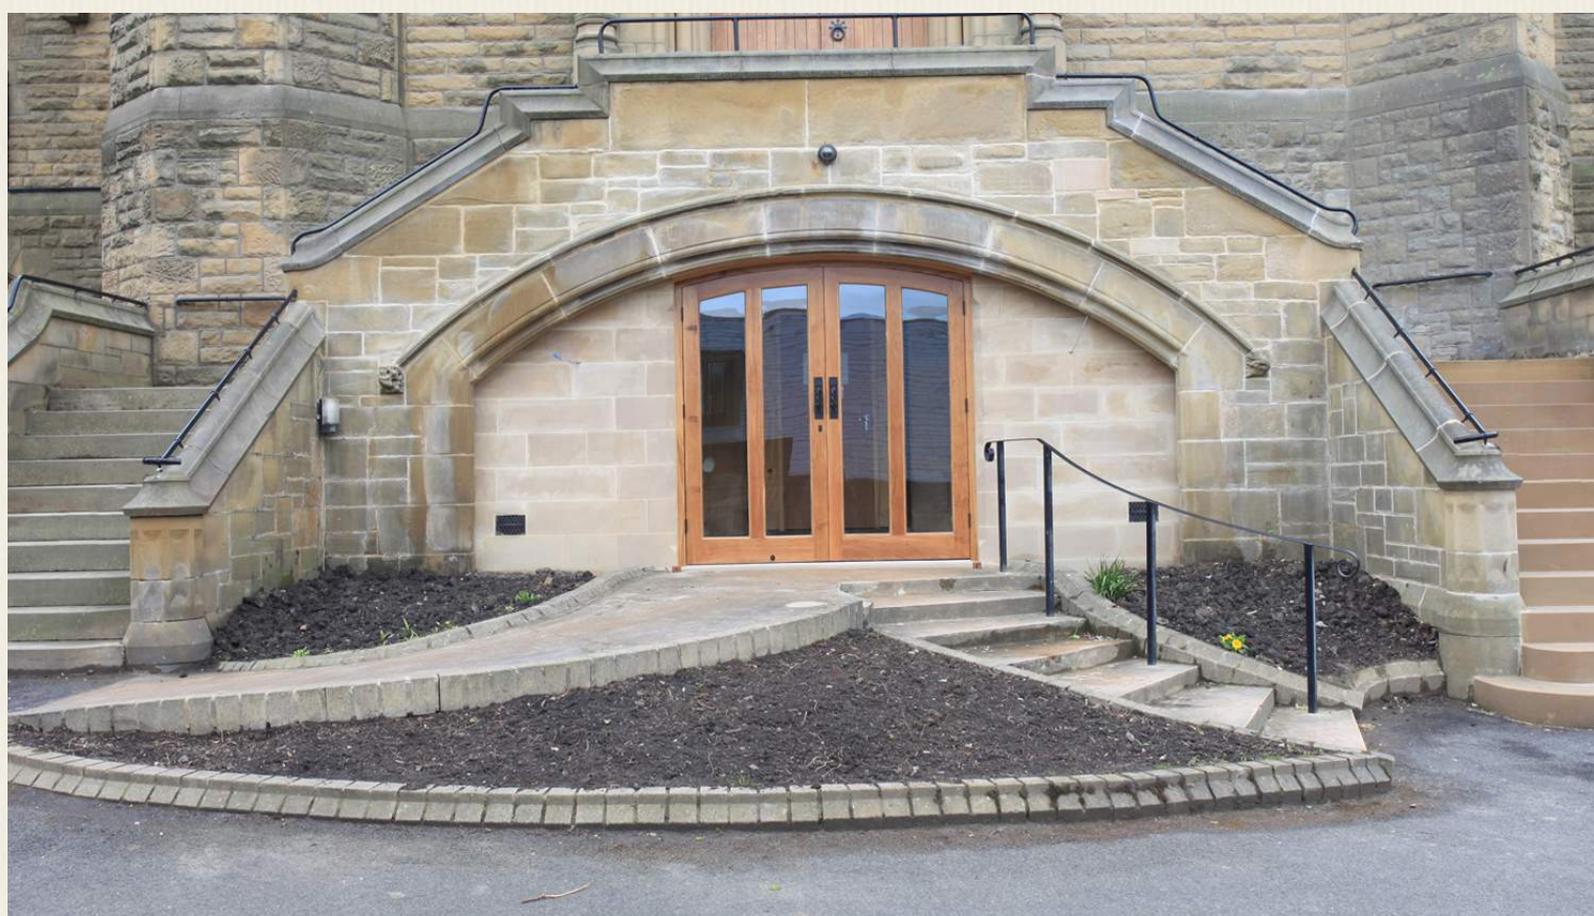
The recessed arch entrance to the Parish Centre was filled in with ashlar facing stone. A double glass panelled door was inserted and the lobby repainted and re-carpeted to match existing.

Parish Centre Entrance
